# The 2<sup>nd</sup> Deep Space Workshop

Key to Success, Lessons Learned, and Things to keep in mind for development in Deep Space Exploration

# Root Cause of Soft-landing Failure in M1 and M2

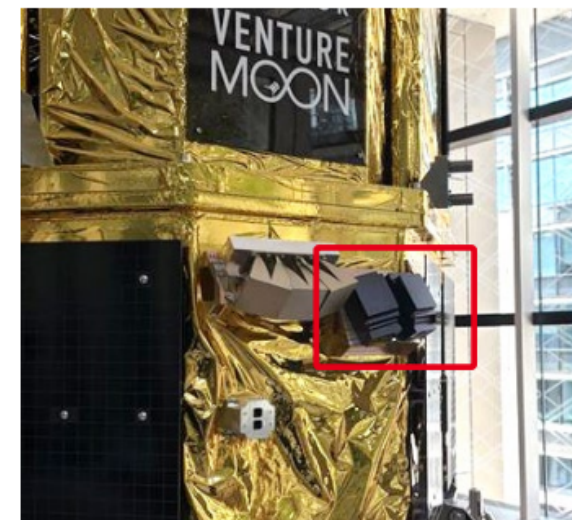
In the above photo, the red frame shows the LRF.  
It is installed on the side of the lander.

While the cause of the soft-landing failure in Mission 1 was software, the cause of the failure in Mission 2 was hardware. Although both involved the same aspect of altitude measurement, the causes were different

Approx. two weeks after the landing failure, a thorough telemetry analysis was conducted, and determined that the LRF was the technical cause. Further factor analysis as part of the development of subsequent missions to be implemented.

- Unexpected performance of LRF during the descent phase
- Hardware failure or performance degradation of LRF during the flight

- Albedo characteristics
- Laser incidence angle and laser output
- Performance at high speeds
- Deterioration due to radiation effects

- **Enhancement of verification strategy and plan** for landing sensors, including LRF
- **Improvement of the selection, configuration, and operation** of landing sensors, including LRF

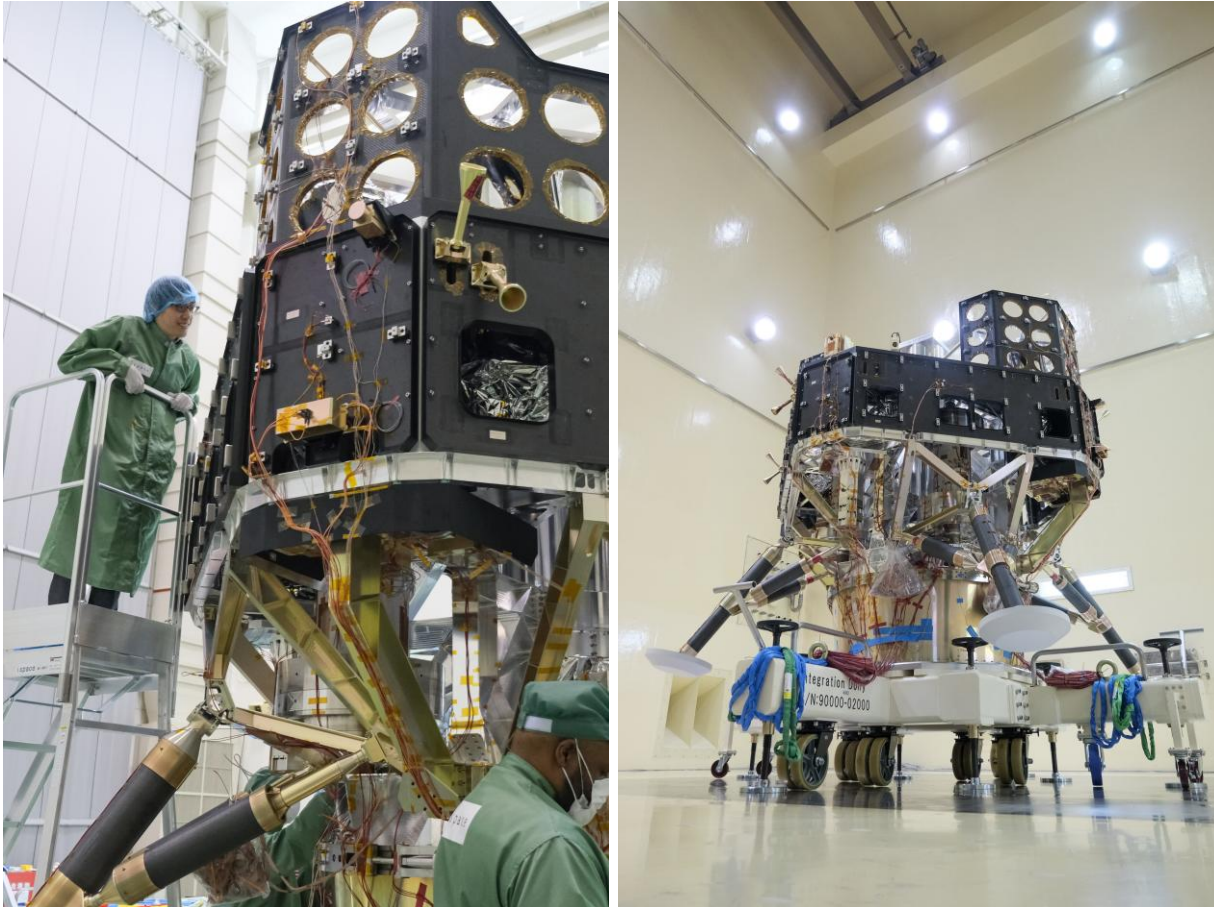
Photos of the structural thermal model of tentatively named Series 3 lander under development with METI's SBIR grant

Approx. 3.6m tall by 3.3m wide (standing, including its legs)

Approx. 1,000kg (Dry: unfueled)

- Vibration testing, to verify resistance to intense vibrations such as those experienced during rocket launch, using a structural thermal model has been completed.
- Drop weight test has been conducted for structural system.
- Thermal control system and structural system tests are currently underway
