The 7th NANO-SATELLITE SYMPOSIUM

“The Overview Report of S-band Ground Station Verification and Operation for Lean Satellite, HORYU-IV”

**BONSU Benjamin, TATSUO Shimizu, HORYU-IV
Project Members, CHO Mengu**
Kyushu Institute of Technology

October 19 , 2016

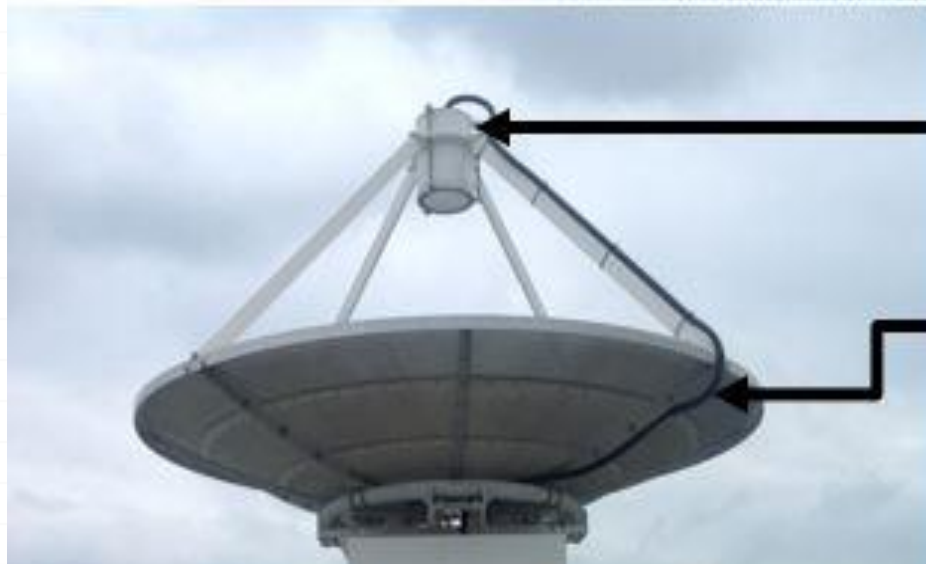
Components of S-band Dish Antenna system

Feed Horn Antenna System

2.4m Parabolic Reflector

Developed and Installed by ELM and Microlab Comapnines

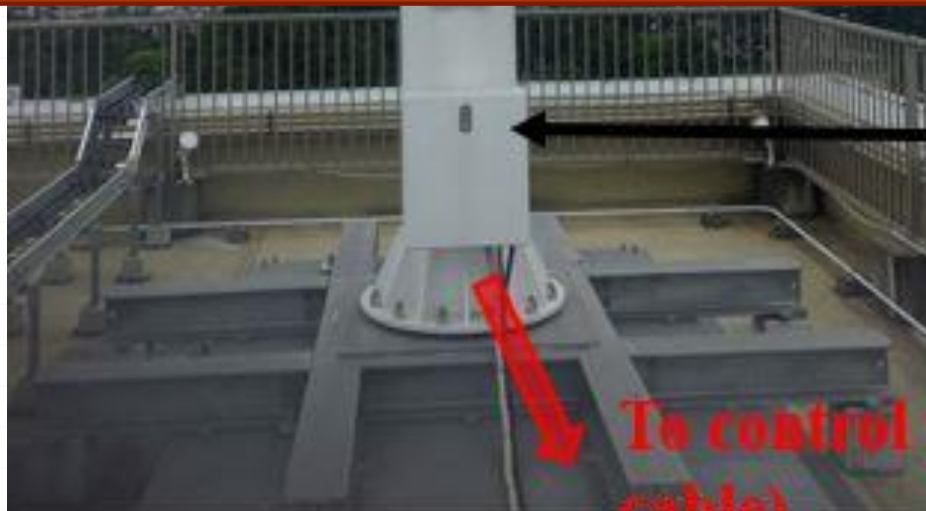
Drive Control Unit

To control room (optic fiber and LAN cable)

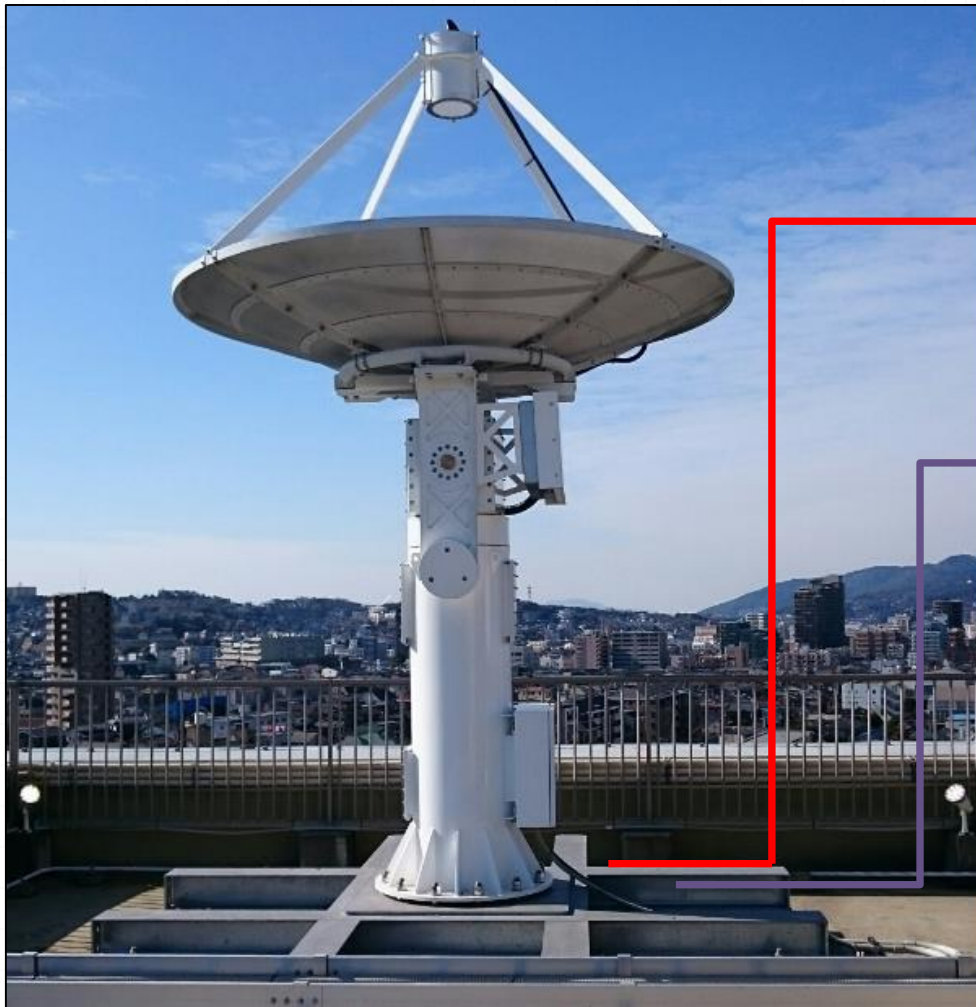
System Diagram of S-band Ground Station Configuration

2.4m S-band Parabolic Dish Antenna System

RF Male N-type connector
 2.4003GHz Optic line
 Ethernet line

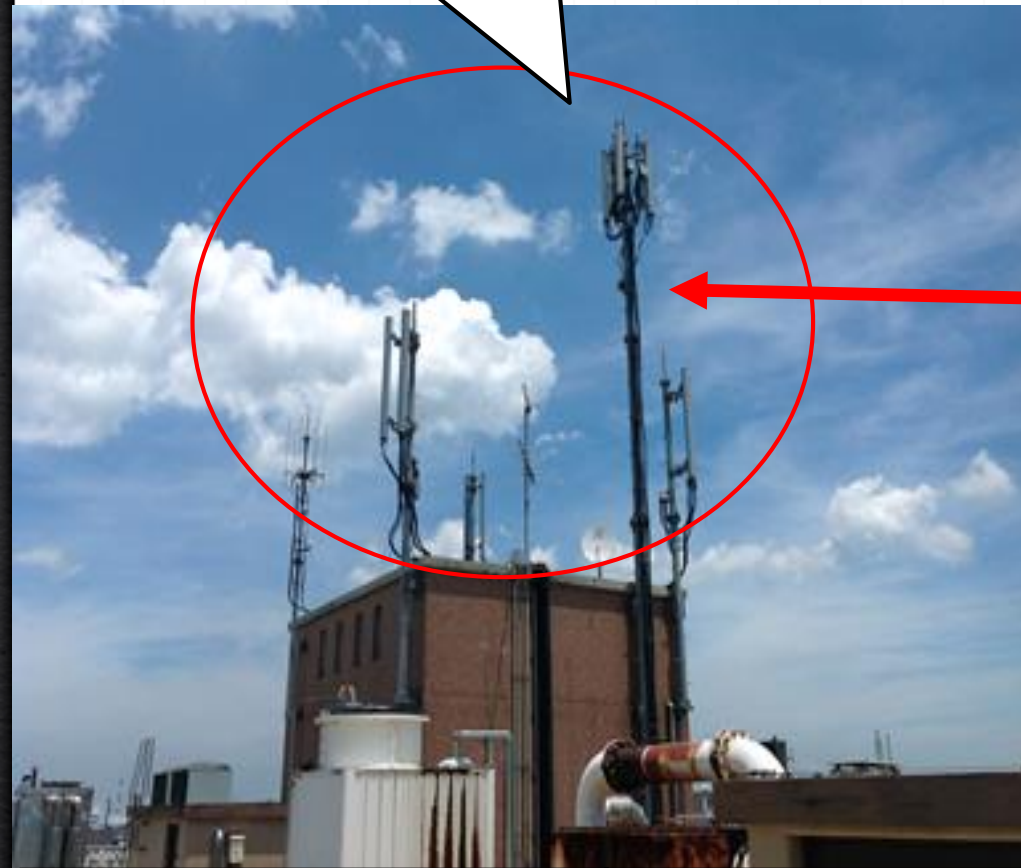
Environmental Interference Test

Wi-Fi, Mobile Phones,
WiMAX radio networks

26 meters

Location: General Research
Building 1 rooftop

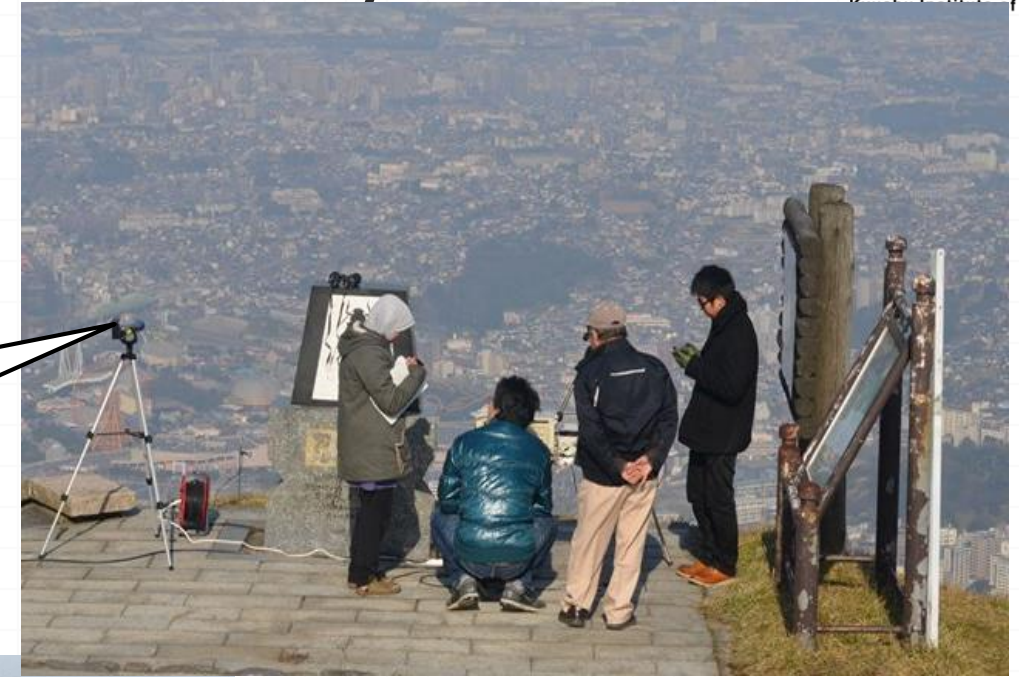
Team at Sarakura Mountain

**Transmitter station
location (Sarakura
Mountain)**

Simulated distance of
2600km (path loss 168.3dB)

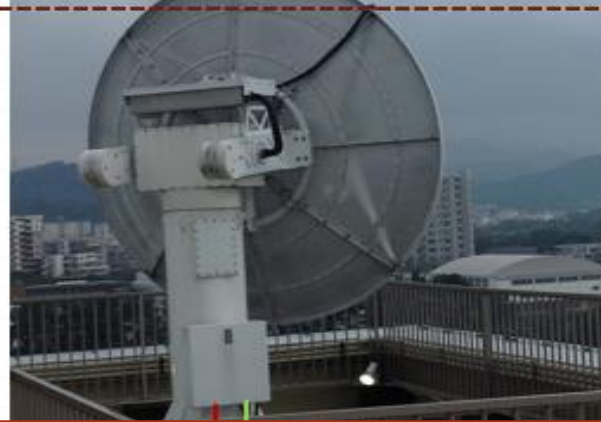
Results of “on-ground” S-band receiver data rate results

**Result: 46kbps > Requirement: 38kbps
PASSED**

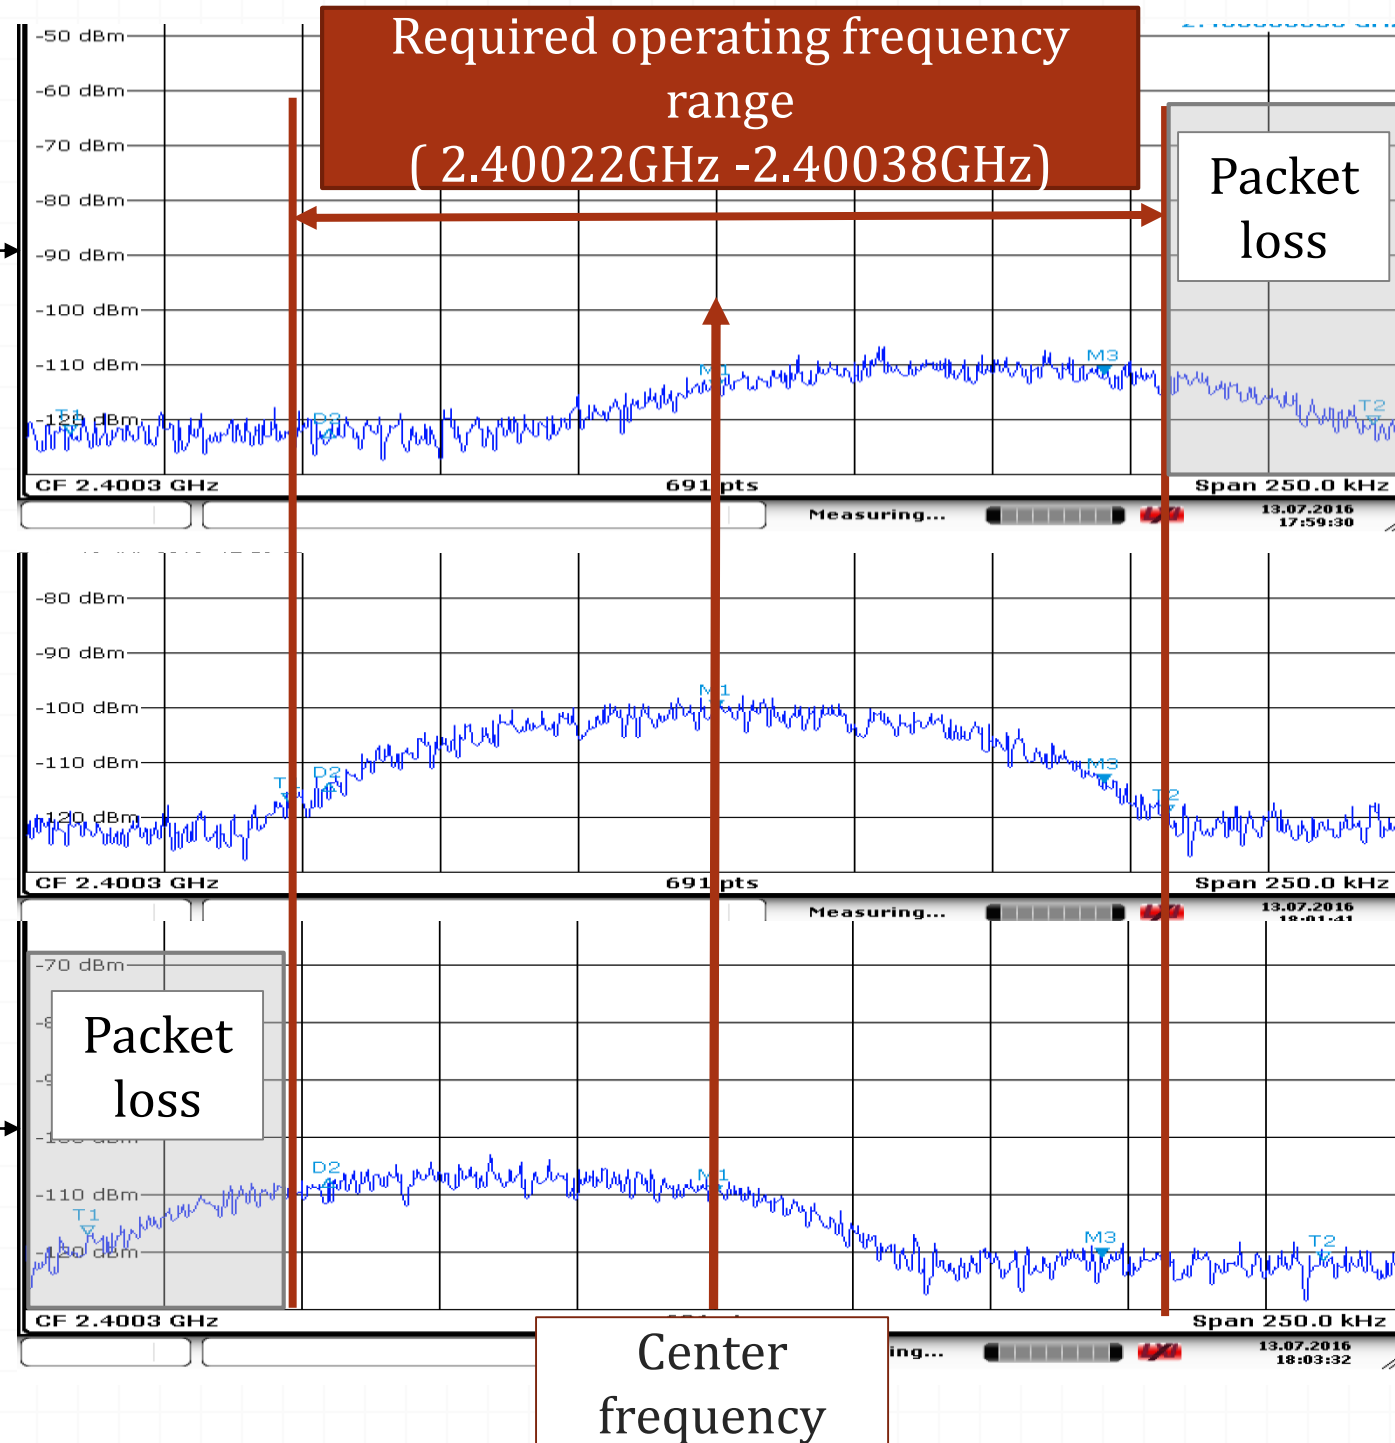
Doppler shift impact on data reception

Frequency shift due to Doppler effect

No Doppler effect

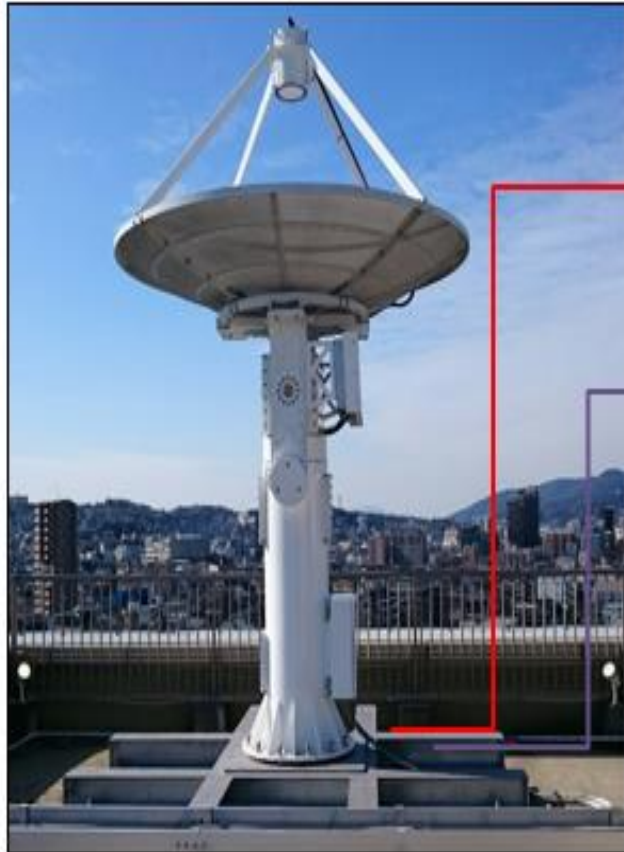
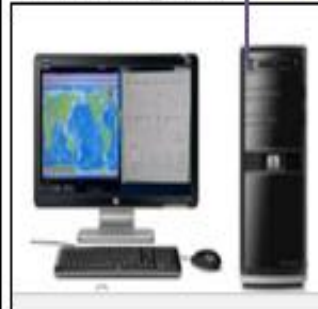
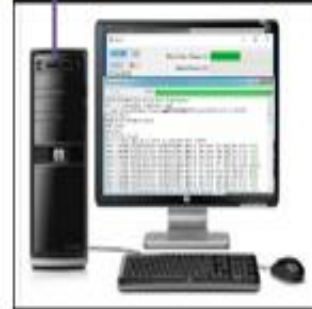
Before Modification

2.4m S-band Parabolic Dish Antenna System

Optical to RF
convertor

S-band Receiver

Ethernet Hub

Tracking PC

Reception PC

— RF Male N-type connector
— 2.4003GHz Optic line
— Ethernet line

Mitigation: Doppler shift correction implementation

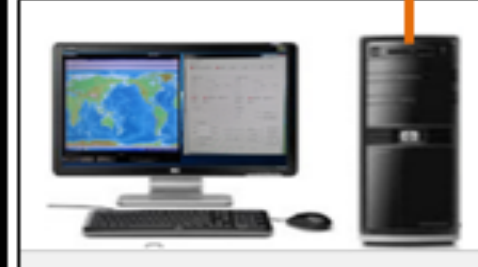
After Modification

Optical to RF
convertor

ICOM R-9500 Receiver

Level
Convertor

Up-Convertor

Signal Generator

S-band Receiver

Tracking PC

— Male N-type connector
— 70MHz RF line
— 10MHz RF line
— 10.7MHz RF line
— RS232 to Analog
Ethernet line
— 80.7MHz RF line

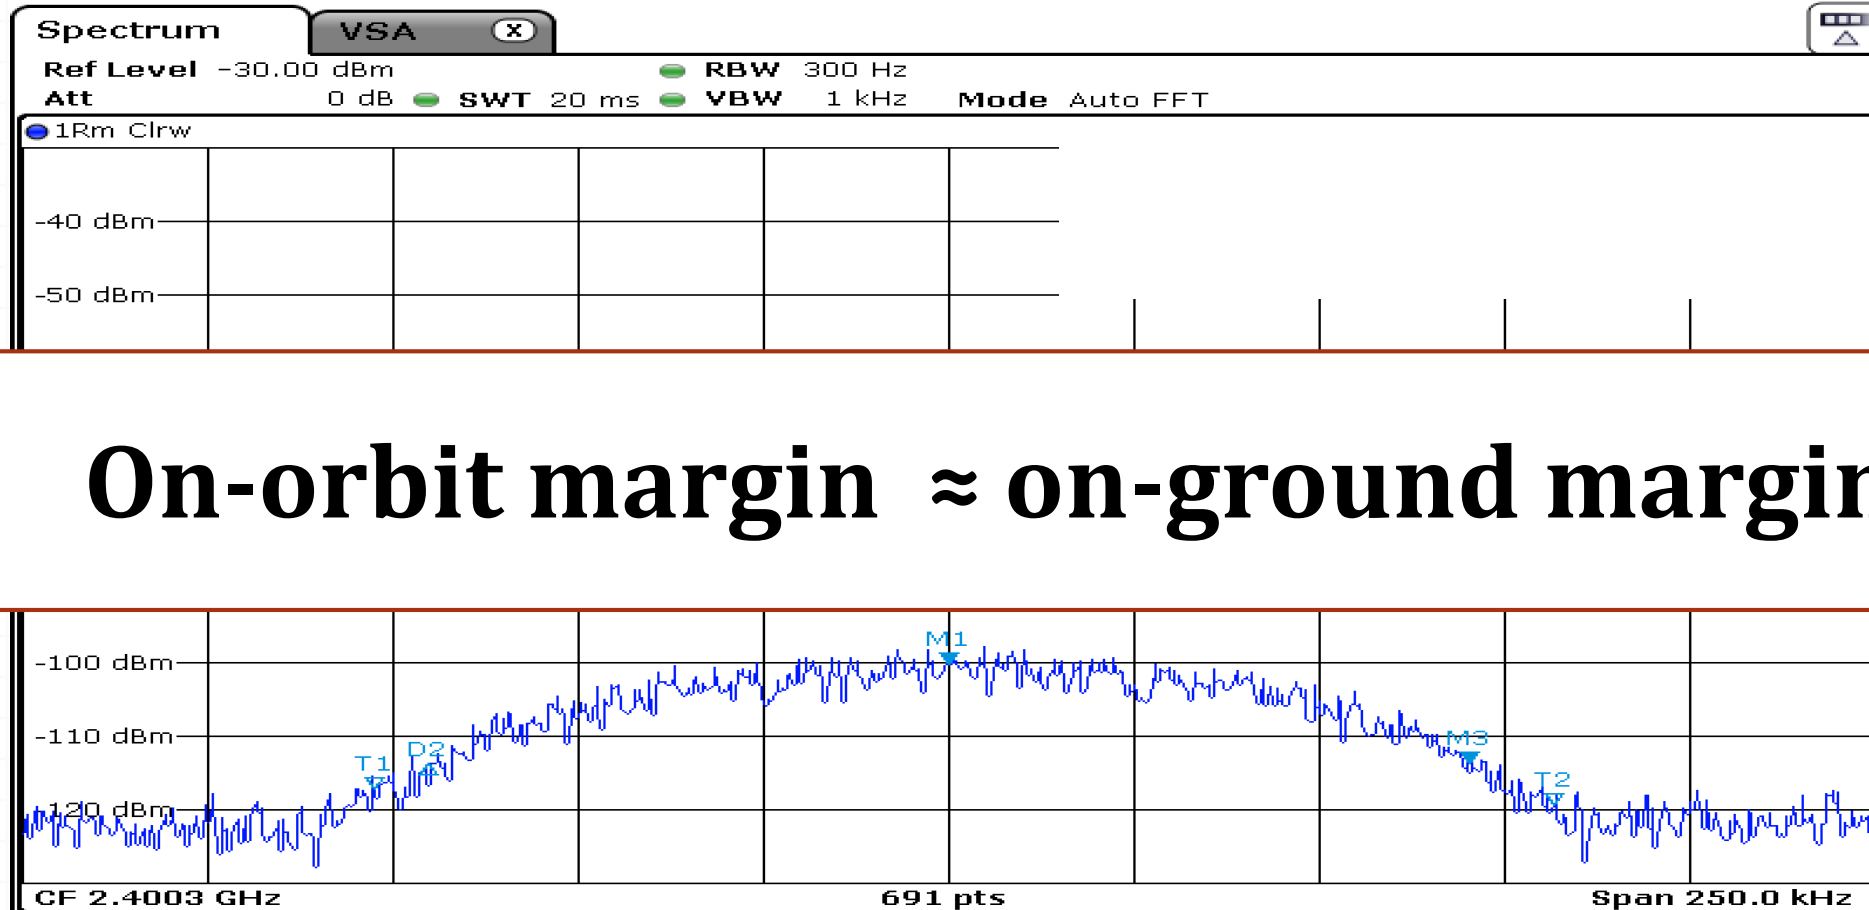
HORYU-IV “on-orbit” Link Margin Analysis Results after Stabilization

Link Margin : 19.62dB

$$\text{Link Margin} = \text{Received } E_b/N_o - \text{Required } E_b/N_o$$

$$\text{Link Margin} = 19.62\text{dB}$$

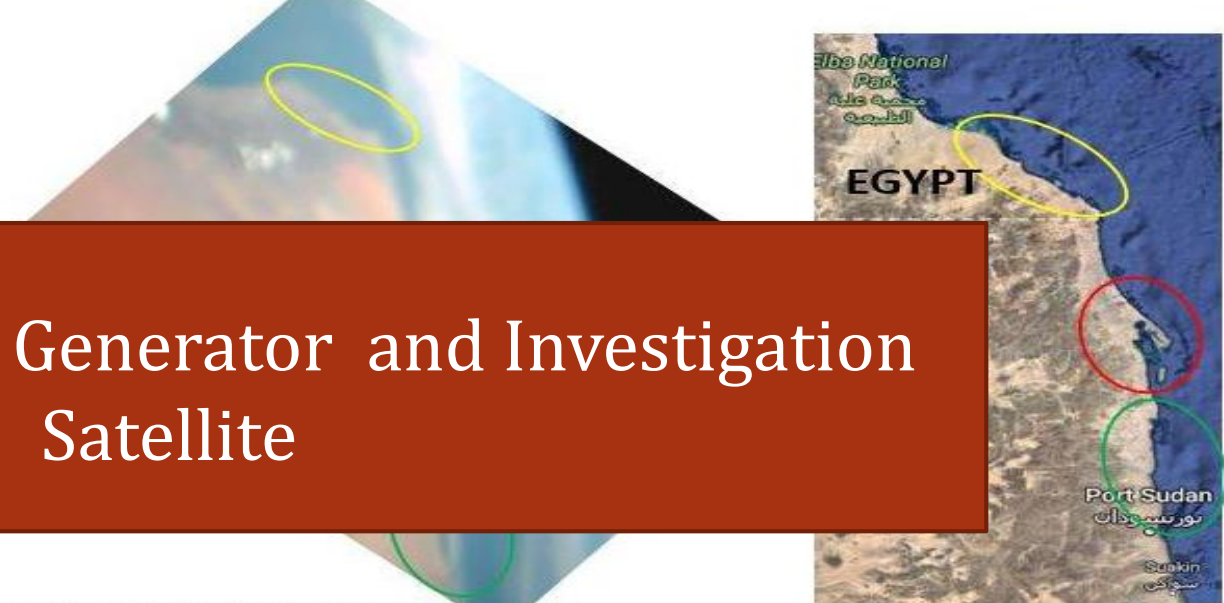
Halayb/Egypt and Port- Sudan Region

HORYU-IV Image

Google Map

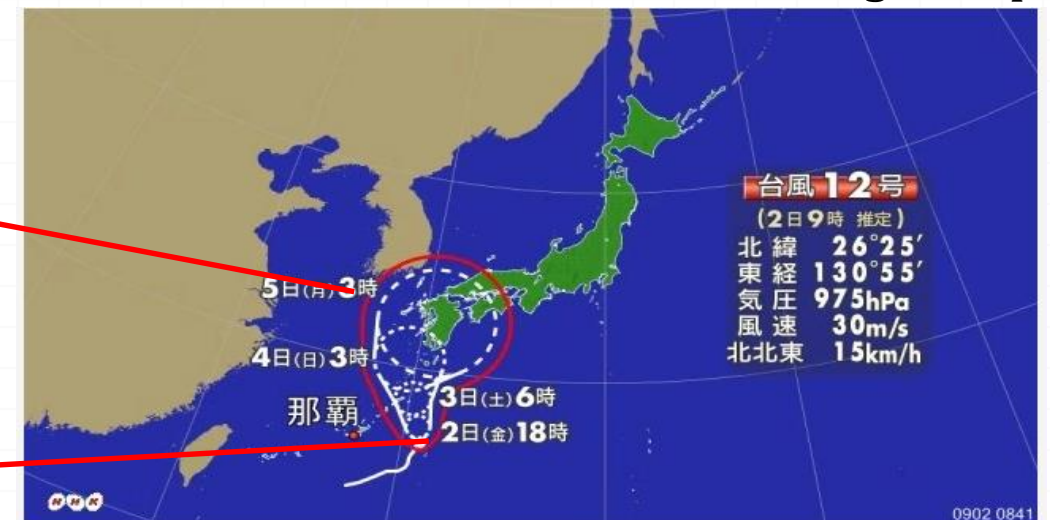
Typhoon image captured on 2nd September during 15:32 JST HORYU-IV pass around Kyushu Island

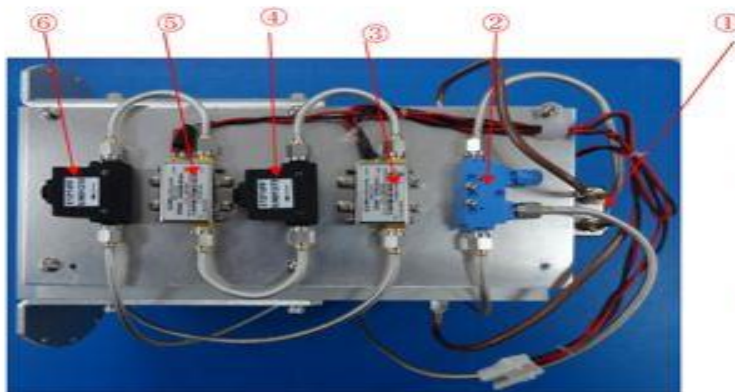
- ① RHCP/LHCP switching relays
- ② RX Test Signal Input for directional couplers
- ③ LNA 1
- ④ Isolators
- ⑤ LNA 2
- ⑥ Isolators
